PROPERTY INSPECTION REPORT

3113 SILVERLAND DRIVE, SAN JOSE

HOME INSPECTION SERVICES CORPORATION
SAN JOSE, CA

July 6, 2010

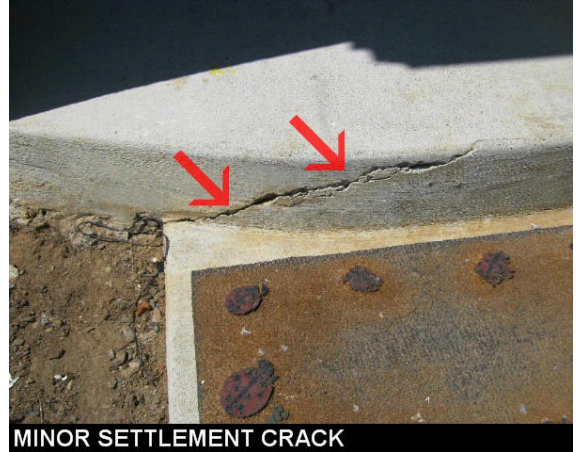
There are minor settlement/expansion cracks noted at the porch area. The cracks should be sealed or patched to prevent further damage due to erosion. The material should be monitored periodically so that preventative measures can be undertaken when needed.

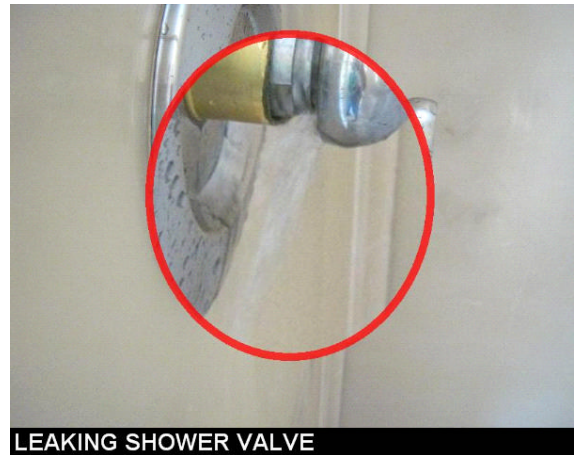
The shower valve is leaking in the Master bath.

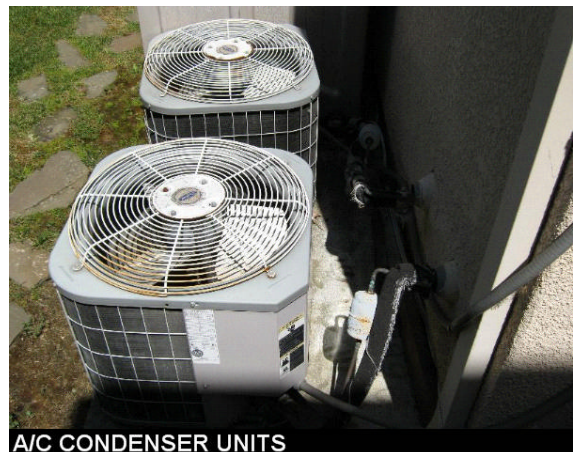
A/C CONDENSER UNITS

The condenser unit(s) is not Secure. This could allow for breakage of the coolant and/or electrical lines.

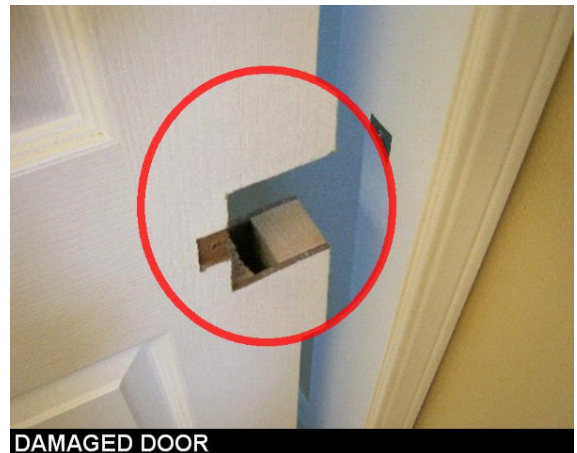
DAMAGED DOOR

The door(s) is damaged. Replacement is generally the preferred method of repair. This was noted at the following location(s): Common bath.
