PROPERTY INSPECTION REPORT

3113 SILVERLAND DRIVE, SAN JOSE

HOME INSPECTION SERVICES CORPORATION
SAN JOSE, CA

July 6, 2010

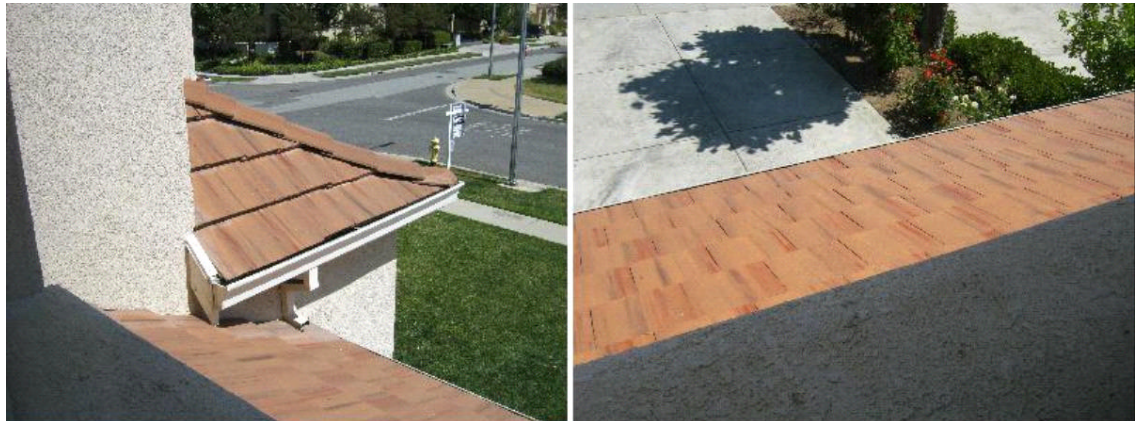
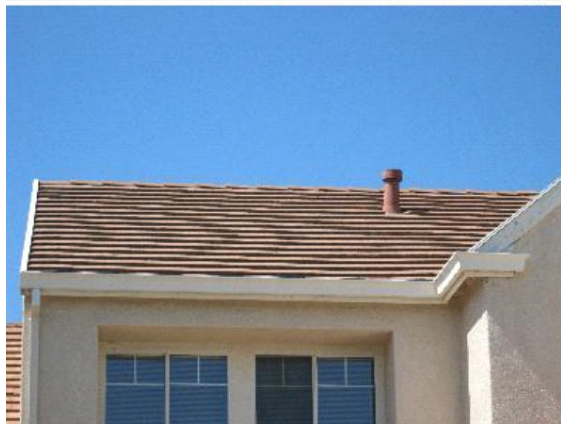
ROOF SURFACE

The roof to this structure is a hip and gable design, with a dura tile type surface. The roof is equipped with metal flashings. The water channeling for the roof is handled by a galvanized steel gutter system. The roof framing is constructed with prefabricated trusses. The supporting roof sheathing is constructed with

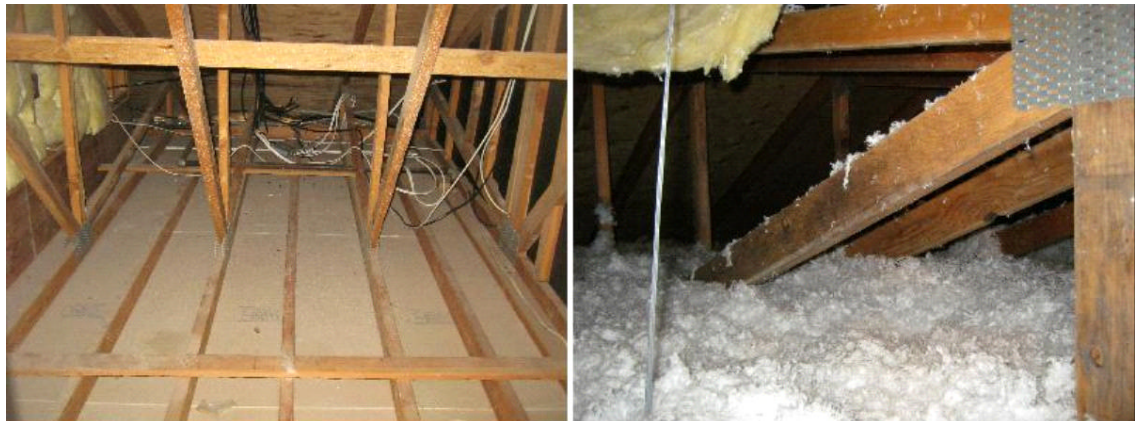
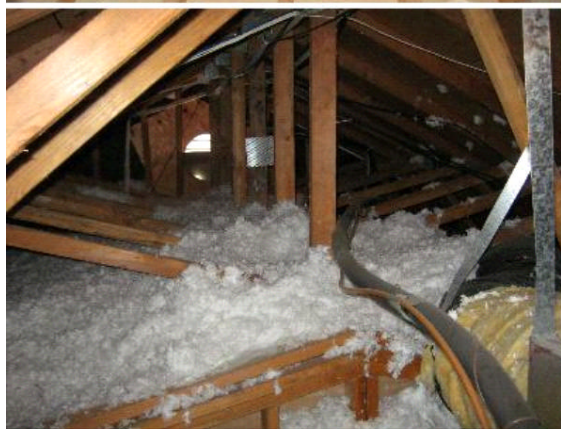
ATTIC AREAS

There are no abnormalities to report.

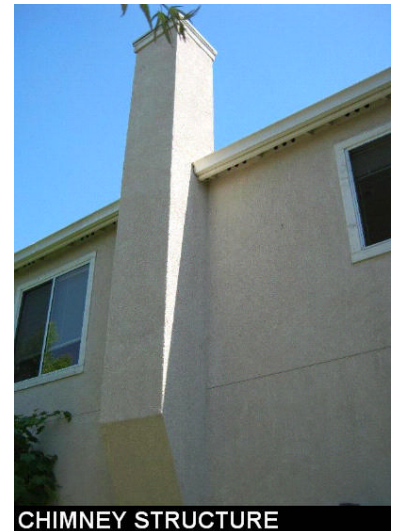
CHIMNEY STRUCTURE

The primary chimney structure has a stucco covering with either a wood frame or concrete block. This could not be determined by a visual assessment. The chimney is fitted with a metal flue. The crown is constructed of metal. The flue termination is equipped with spark cap, arrester, or rain hood.

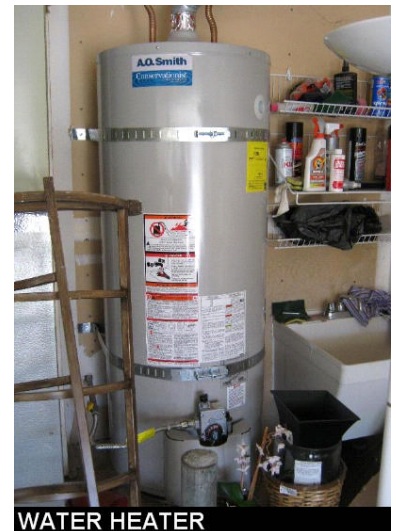
WATER HEATER

The primary water heater provided for the structure is a natural gas fired unit. The unit has a capacity of 50 gallons. The appliance is located in the garage. The unit has a water shutoff valve. The unit has a water shutoff valve. The unit has an installed PTR valve. (this device cannot be tested during the inspection)

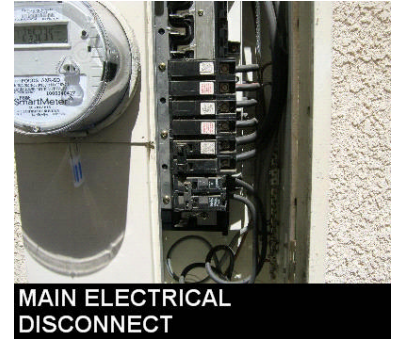
**MAIN ELECTRICAL DISCONNECT****MAIN PANEL: Sec 7.4***Comments: SERVICEABLE:*

There are no abnormalities to report.

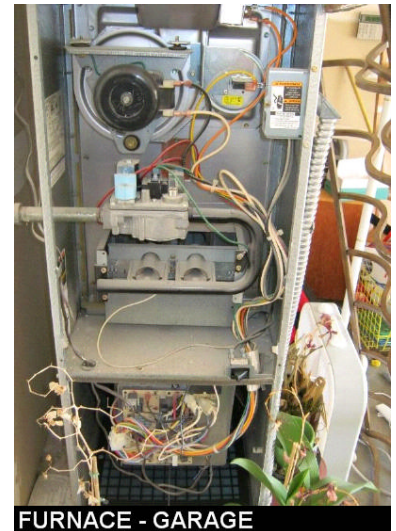
Primary Furnace

The structure is provided with a warm air forced system. The system operates on natural gas. The circulating air filter is installed in the plenum in the blower cabinet at the bottom of the furnace. The duct work provided for the system is through flexible fiberglass wrapped ducts. The thermostat controls the furnace and air conditioning unit. The primary furnace was located in the following location: Garage.

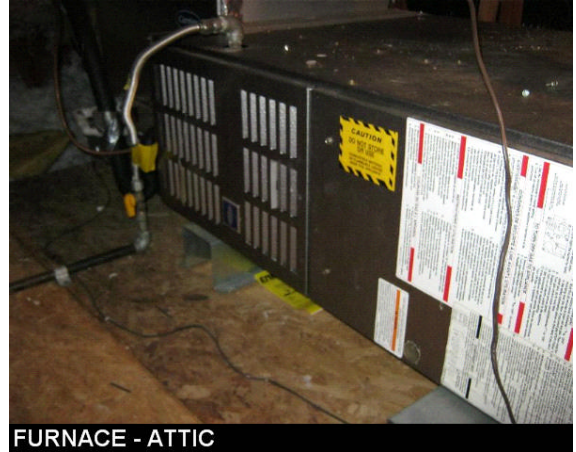
FURNACE - ATTIC

The structure is provided with a second a warm air forced system. The system operates on natural gas. The circulating air filter is installed behind the air intake register. The duct work provided for the system is through flexible fiberglass wrapped ducts. The thermostat controls the furnace and air conditioning unit. The primary furnace was located in the following location: Attic.
